MR scanning of patients with temporary external pacemakers: Two case studies

Authors: Caitlin O'Brien, Alan Wright, John Maynard, Tevfik F Ismail

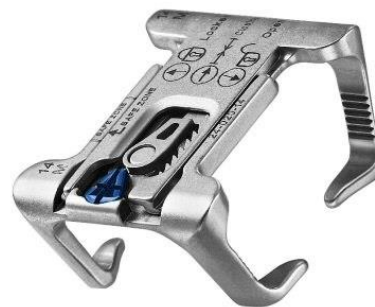
Figure 1: KLS Martin Sternal Talon

The MR Unlabelled KLS Martin Sternal Talon was highlighted as a potential higher risk implant in this category, due to the perceived increased risk of heating at the tips. If a patient has a sternal fixation device within the MRI field of view, the GISP recommends considering interleaving high and low SAR sequences but would consider this low risk.

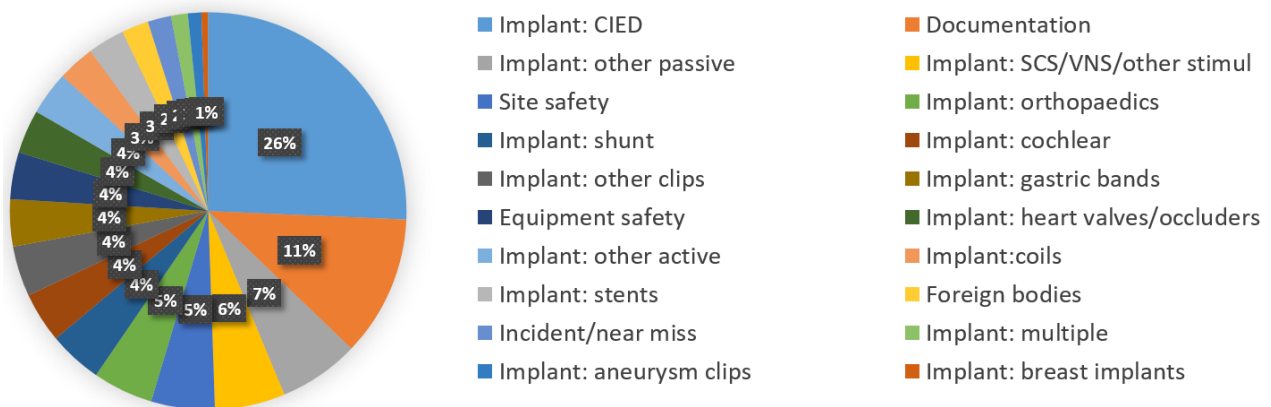
Fig 1: Safety queries (Aug 2020-Jul 2023)

Methods. All safety queries submitted to the ticketing system were queried and classified according to the predefined logging categories (Fig 1). The cardiac implantable electronic devices (CIED) queries were then further divided according to the MRI status of the device (MR Conditional vs not MR Conditional, so off label required for scanning) and plotted over time. Two key local events in the timeline (the approval of a set of MR Conditional CIED checklists, and the approval of an off label CIED MR Protocol) were also marked in the timeline graph (Fig 2).

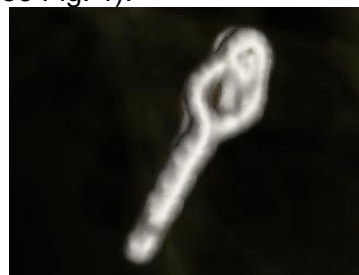
(b) Helical CT 3D reconstruction
